Effects of Late Holocene Debris Flows on Lava Falls Rapid, Grand Canyon National Park, Arizona

U.S. GEOLOGICAL SURVEY
Open-File Report 96—460

By ROBERT H. WEBB, THEODORE S. MELIS, THOMAS W. WISE, and JOHN G. ELLIOTT

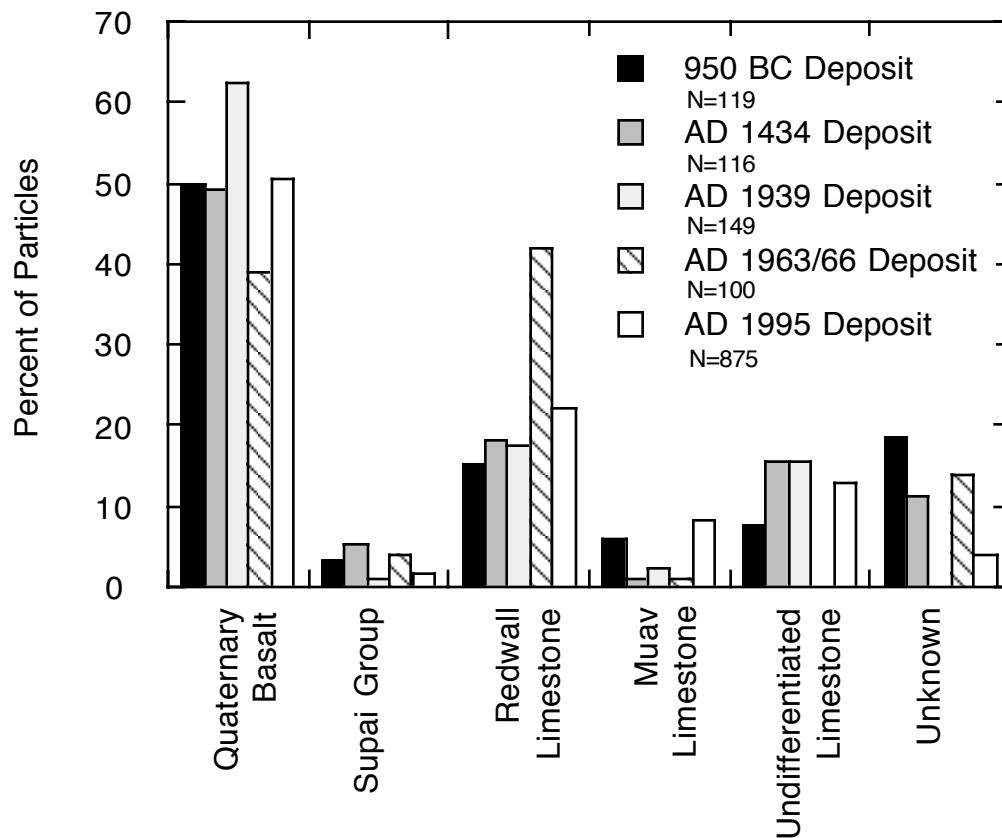
Figure 5. Source materials transported by debris flows in Prospect Canyon.

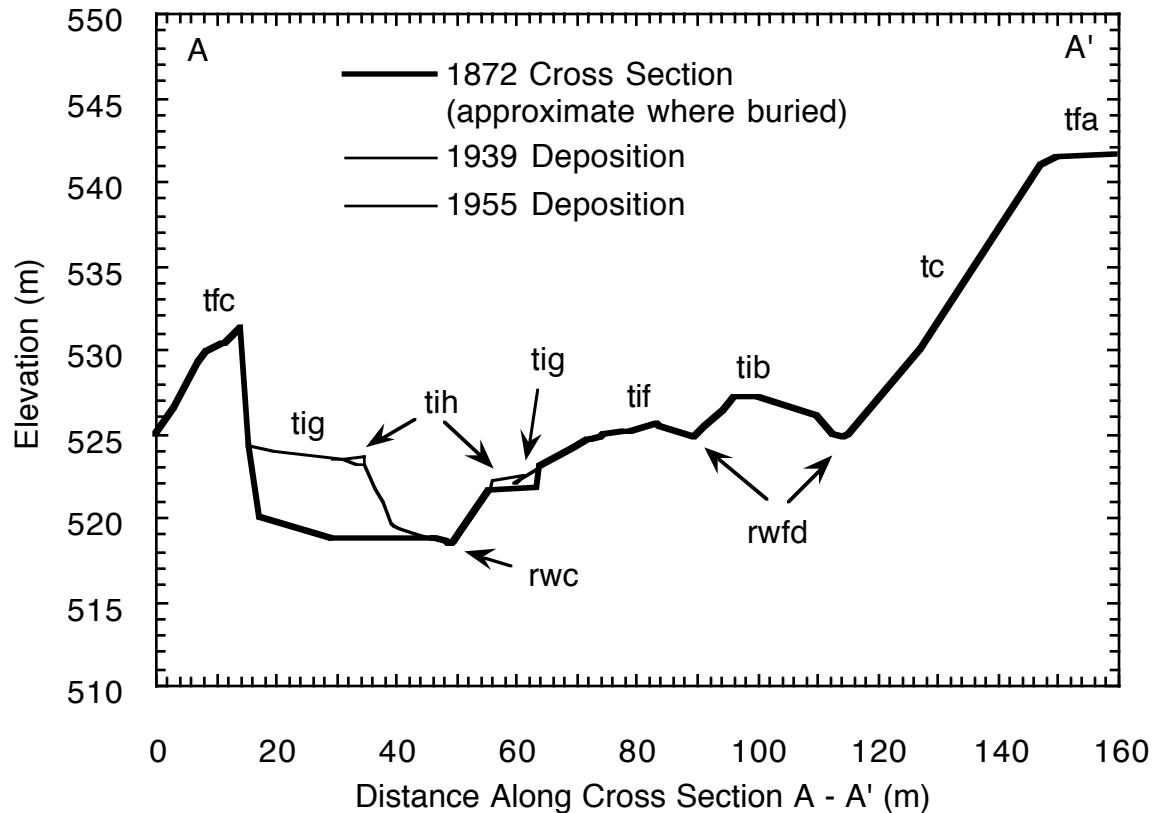
Figure 6. Cross section showing the relative elevations and positions of fan-forming and inset debris-flow surfaces along A - A' (see Plate I).

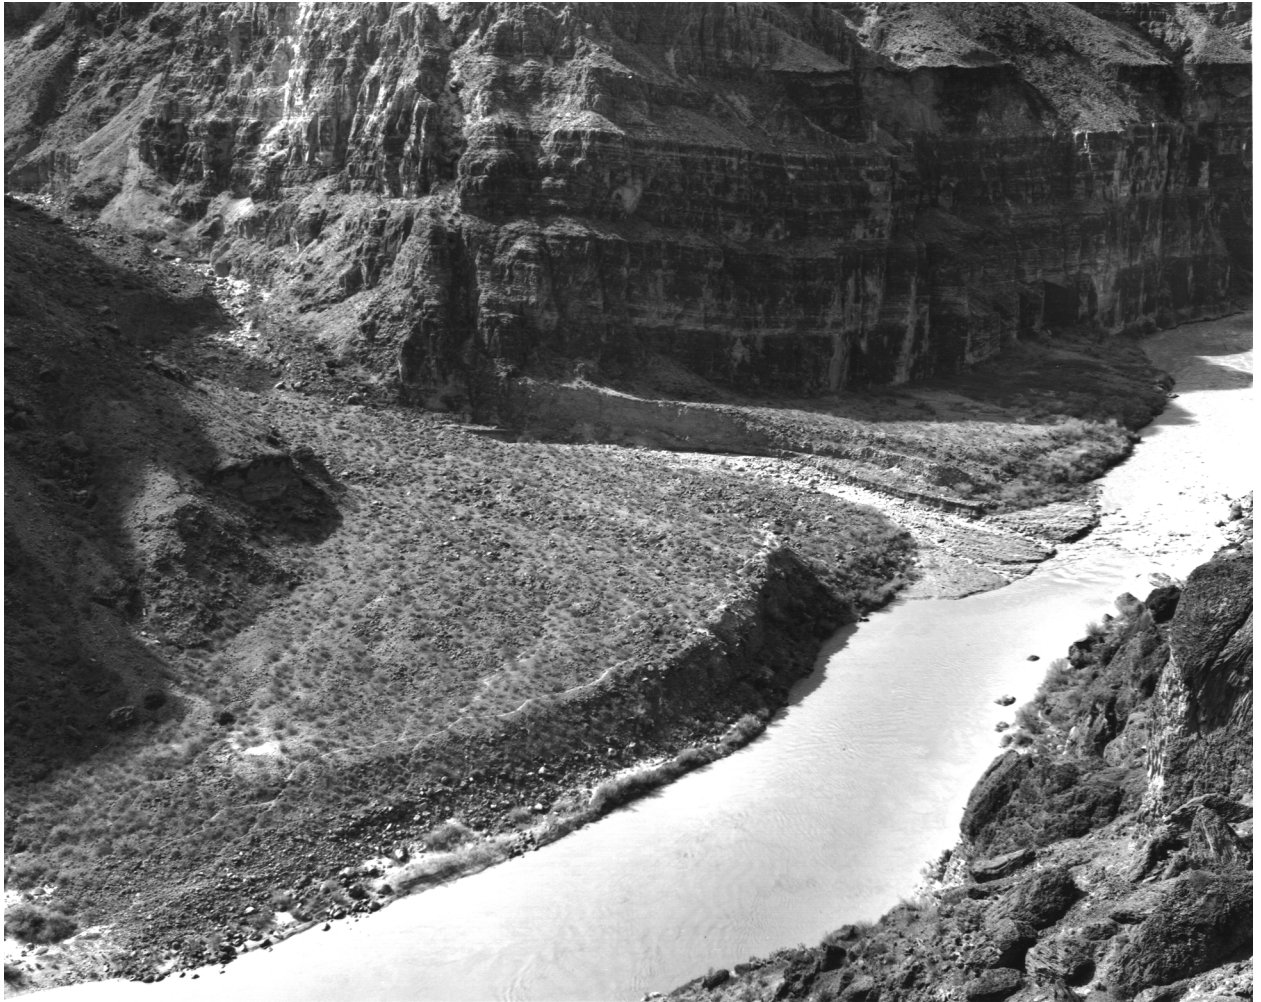
Figure 7. View of the Prospect Canyon debris fan on March 7, 1995 (S. Tharnstrom). Surface tfa dominates the left center of the view. Deposition from the 1995 debris flow appears at right center adjacent to the rapid.

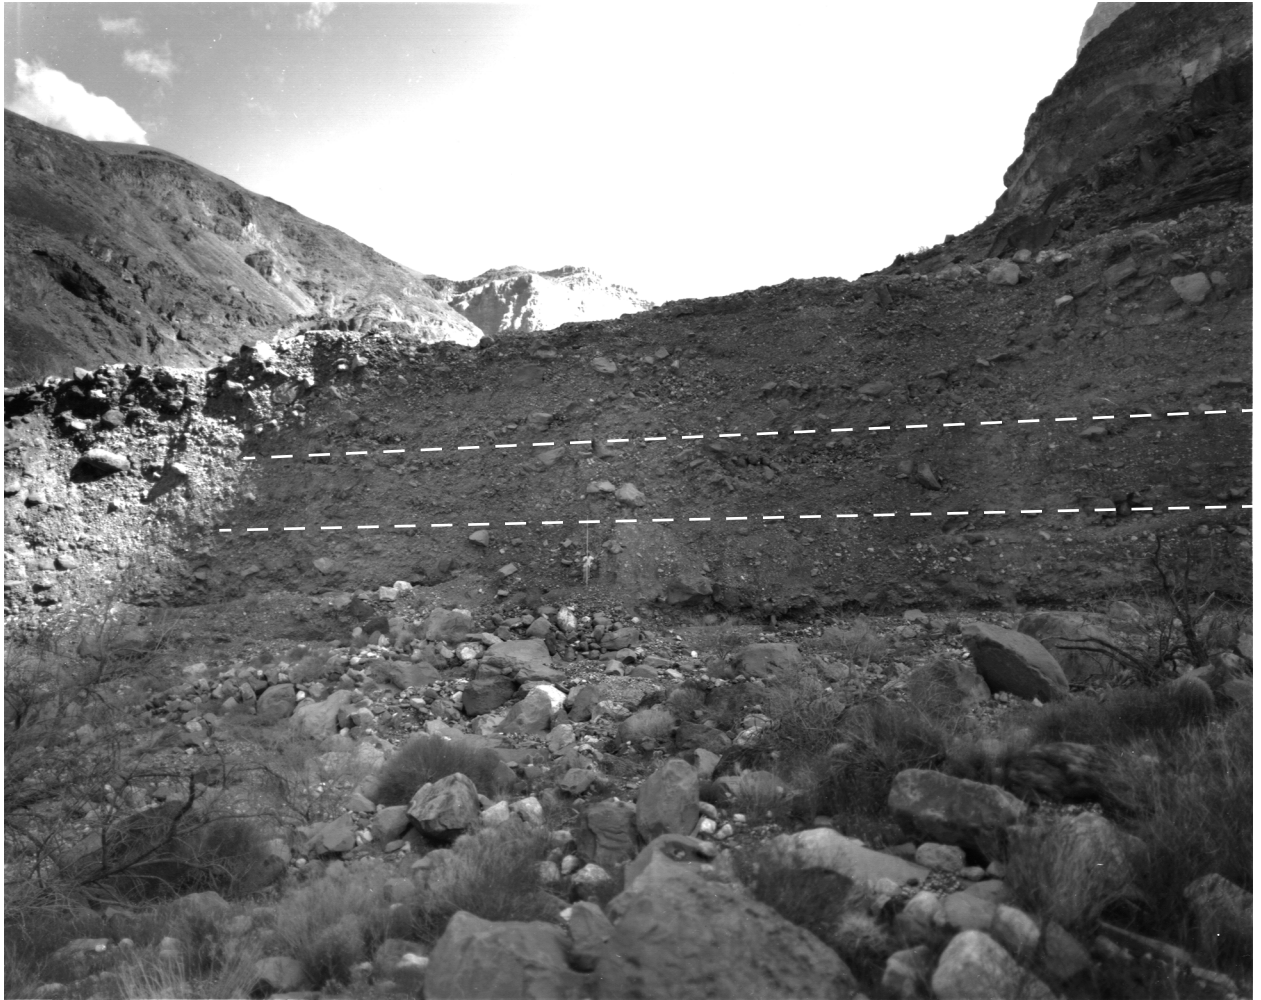
Figure 8. Stratigraphy of surface tfa on the Prospect Canyon debris fan. Dashed lines indicate the approximate contact points between stratigraphic layers.

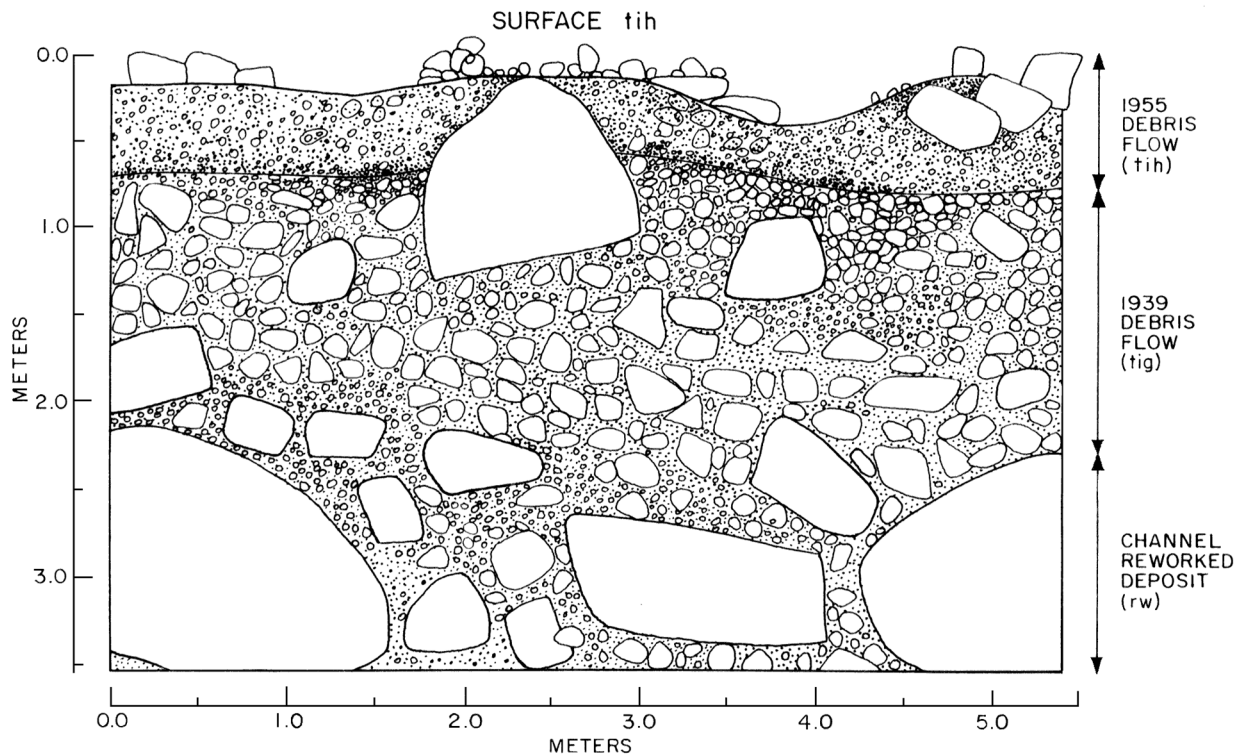
Figure 10. Stratigraphy of the 1955 debris-flow deposits (surface tih). The 1955 debris-flow deposit (0.6-1.0 m thick, tih) overlies the 1939 deposit (0.3-2.0 m thick). Stratigraphic breaks are faint, particularly between the 1939 deposit (tig) and the underlying reworked channel deposits.

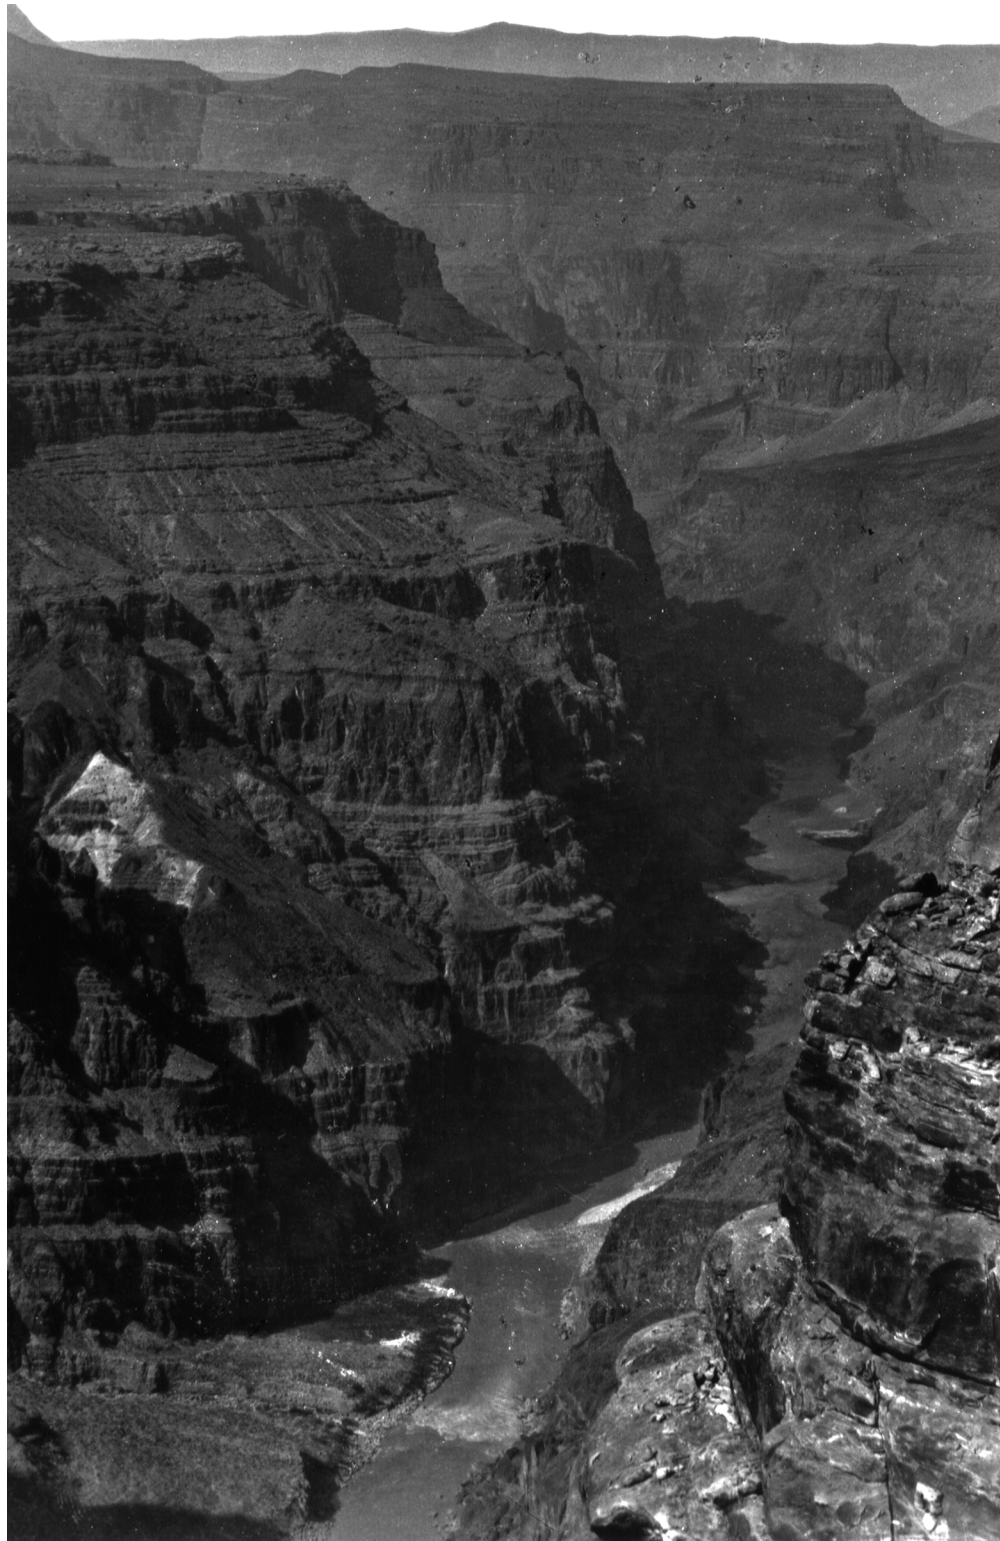
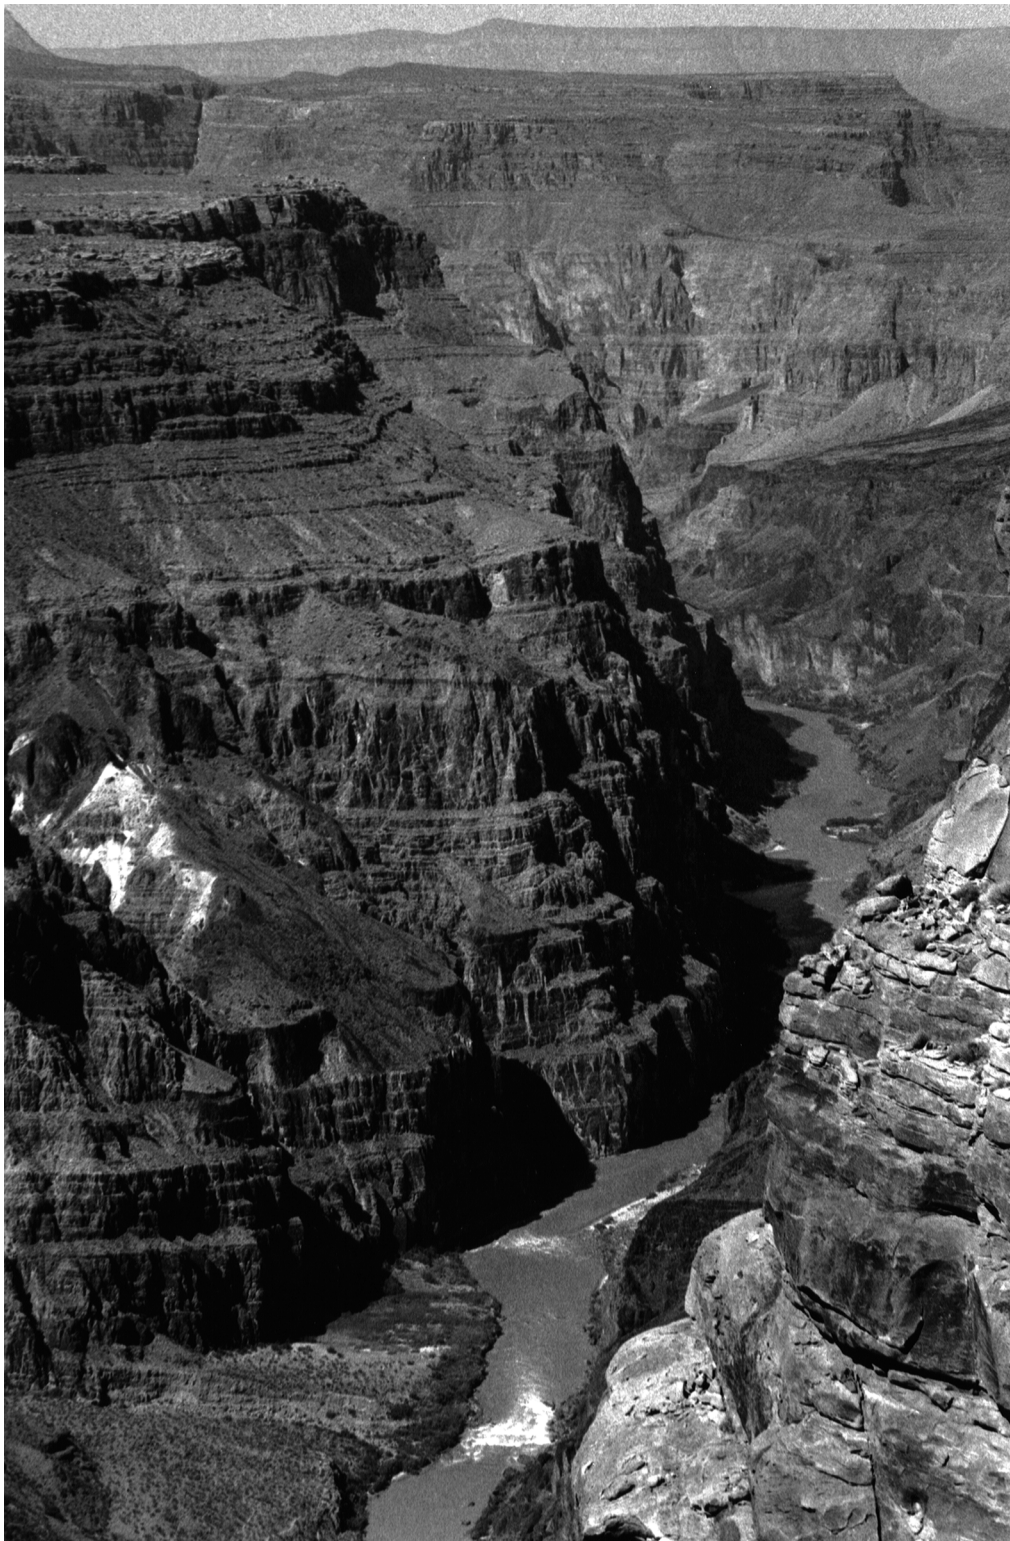
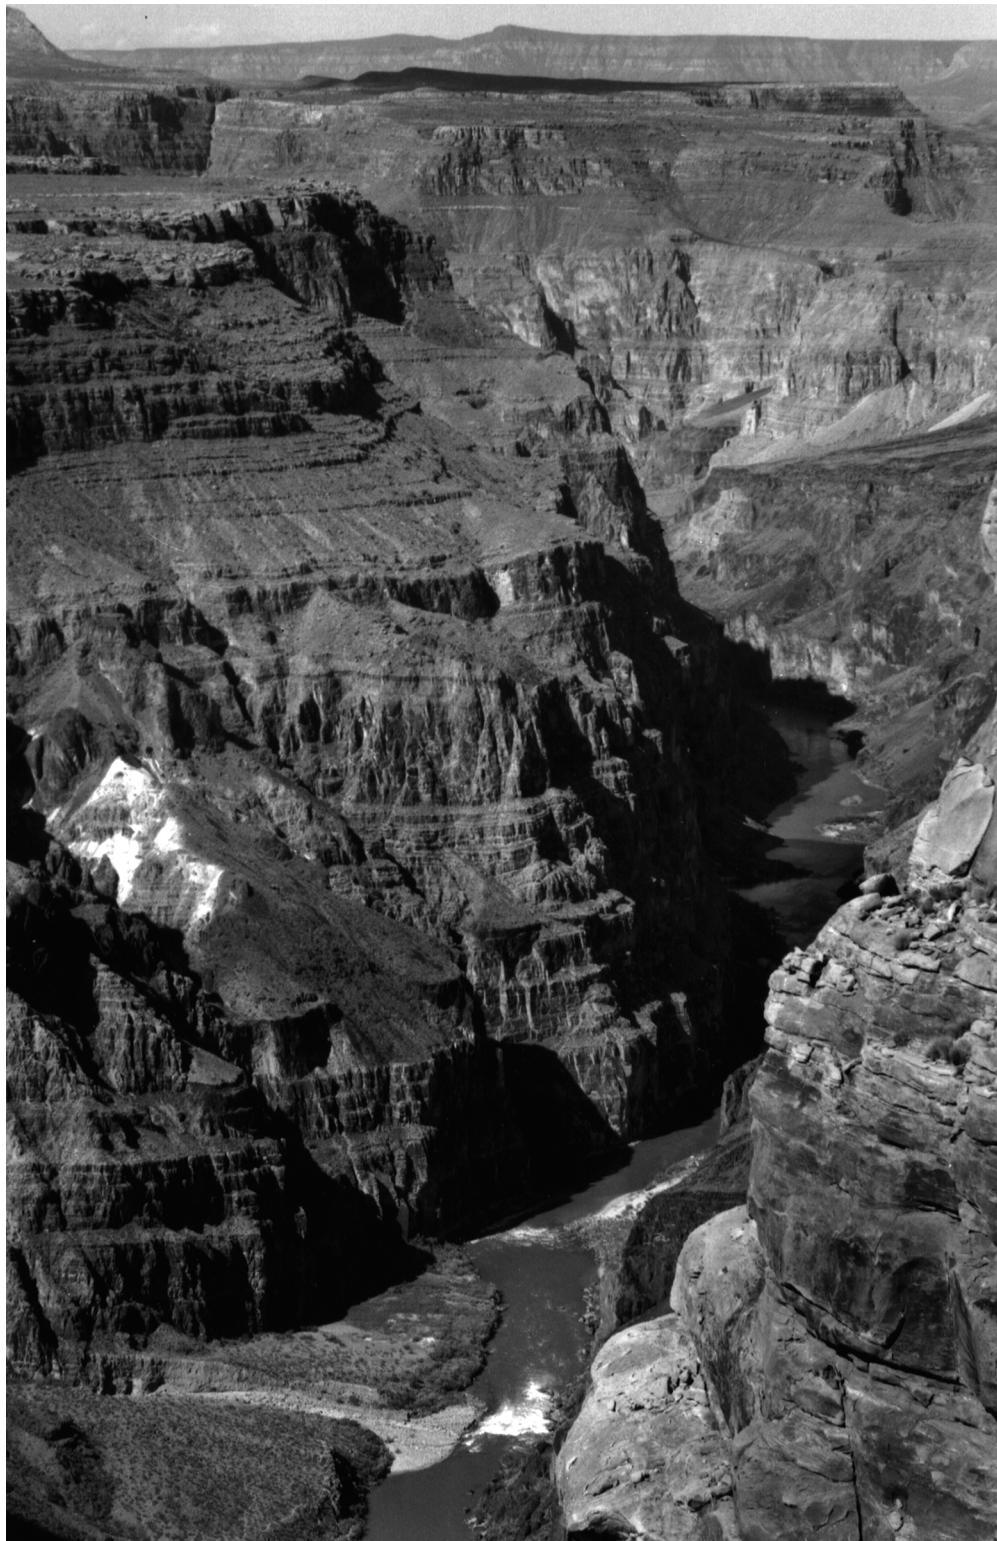
Figure 12. Downstream view of Prospect Canyon and Lava Falls Rapid from Toroweap Overlook (Stake 967). A. (April 16, 1872; J.K. Hillers, courtesy of the National Archives). Lava Falls Rapid as viewed by the Powell Expedition was completely different from the rapid now familiar to thousands of whitewater enthusiasts. Using photogrammetric rectification, we found that the rapid began 85 m farther downstream on the left side, and the head of the rapid formed a line perpendicular to flow. A prominent tongue of water entered the left side of the rapid, and its tail waves at the bottom flowed directly downstream. At the discharge shown (approximately $300 \text{ m}^3/\text{s}$), the area of the exposed debris fan is about 0.2 ha.

B. (June 10, 1979; R.M. Turner). After a series of debris flows from 1939 through 1966, Lava Falls Rapid changed substantially. At a discharge of about $340 \text{ m}^3/\text{s}$ in 1979, the head of the rapid slanted downstream to the right side, and the main tongue was on the right side. The tail waves were much farther downstream and curved towards the left. Two distinct levees in the mouth of Prospect Canyon were deposited between 1872 and 1966; the largest levee was deposited by the 1939 debris flow, and the smaller, inset levee is remnant channel fill from the 1963 and 1966 debris flows. The debris-flow deposits in the mouth of Prospect Canyon are overgrown with dense riparian vegetation.

C. (May 16, 1995; R.M. Turner). The debris flow of March 6, 1995, initially constricted the Colorado River by 62 percent, but reworking quickly widened the river and reduced the constriction, as shown here, to about 50 percent. The constriction increased the drop through Lava Falls Rapid, accentuating its hydraulics, but some formerly prominent waves, such as the Big Wave, were not present. The 1963 and 1966 debris-flow deposits were completely eroded from the margins of Prospect Canyon. At this discharge of about $260 \text{ m}^3/\text{s}$, the exposed area of the new debris fan is 0.62 ha.

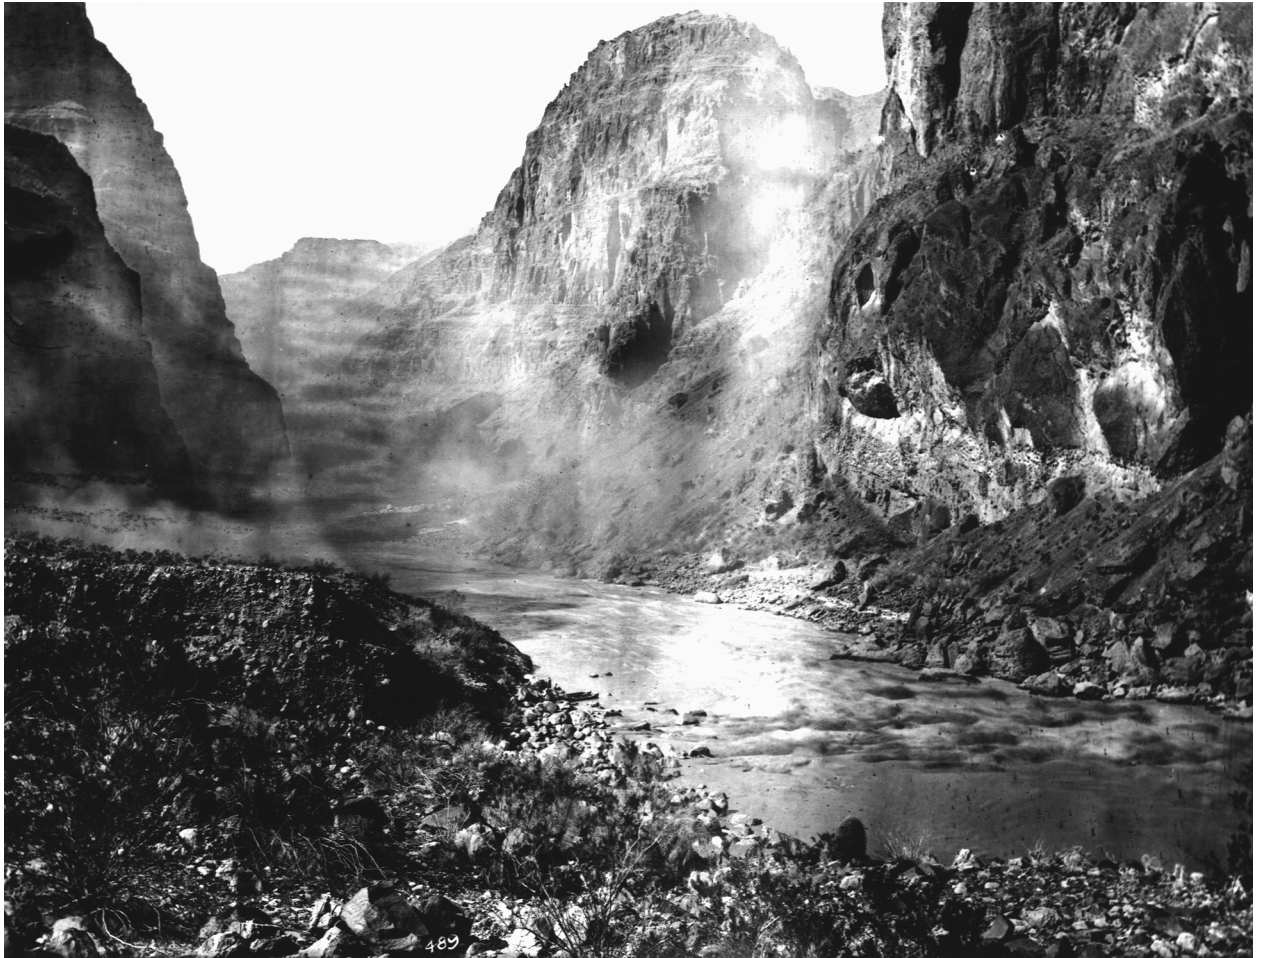
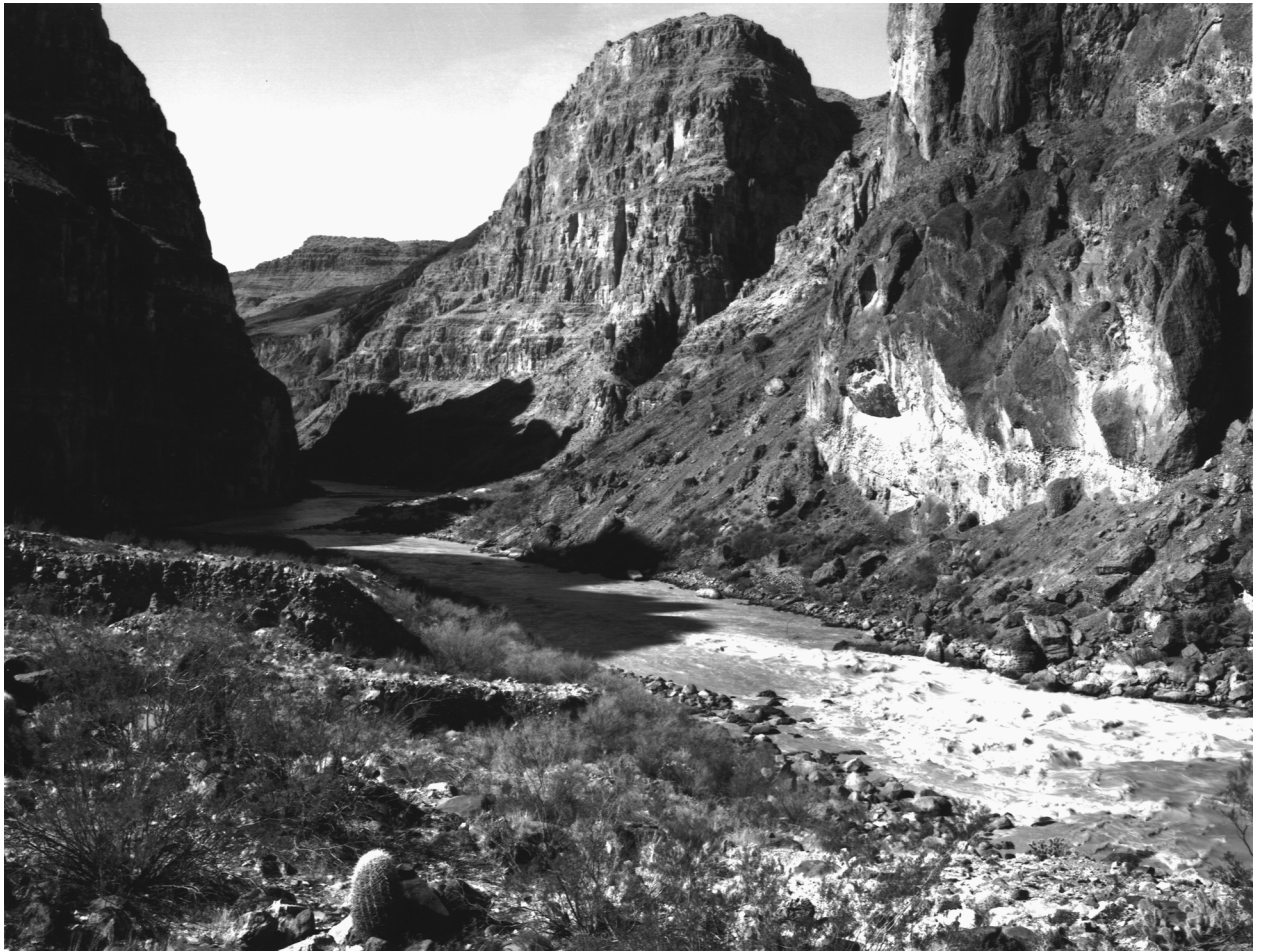
Figure 13. Downstream view of Lava Falls Rapid from the high surface on the left side (Stake 1510b). The channel of Prospect Canyon, which enters the Colorado River from the left, appears in the center of the view. A. (February 27, 1890; R.B. Stanton, courtesy of the National Archives). The last vestiges of smoke from a large fire set by the Stanton expedition are shown at left center. The left side of the rapid has flat, relatively slow-moving water adjacent to the mouth of Prospect Canyon. The Deflector Rock is visible on the right side approximately 15 m upstream from the Black Rock. Tail waves from the rapid are deflected away from the Black Rock and the main flow is down the center of the rapid. The water level is 280-400 m³/s.

B. (February 11, 1990; R.M. Turner). Debris flows from Prospect Canyon changed the rapid substantially in the 20th century. The rapid now begins farther upstream. The 1939 debris flow deposited the prominent low surface at left center. Deposition during the 1939 event forced flow through the rapid to the right; the Deflector Rock moved downstream and was submerged at most water levels. The Black Rock deflects typical dam releases to the left. Debris flows in 1954, 1955, 1963, and 1966 deposited sediment along the left side of the rapid, changing a relatively quiescent area to whitewater choked with boulders.

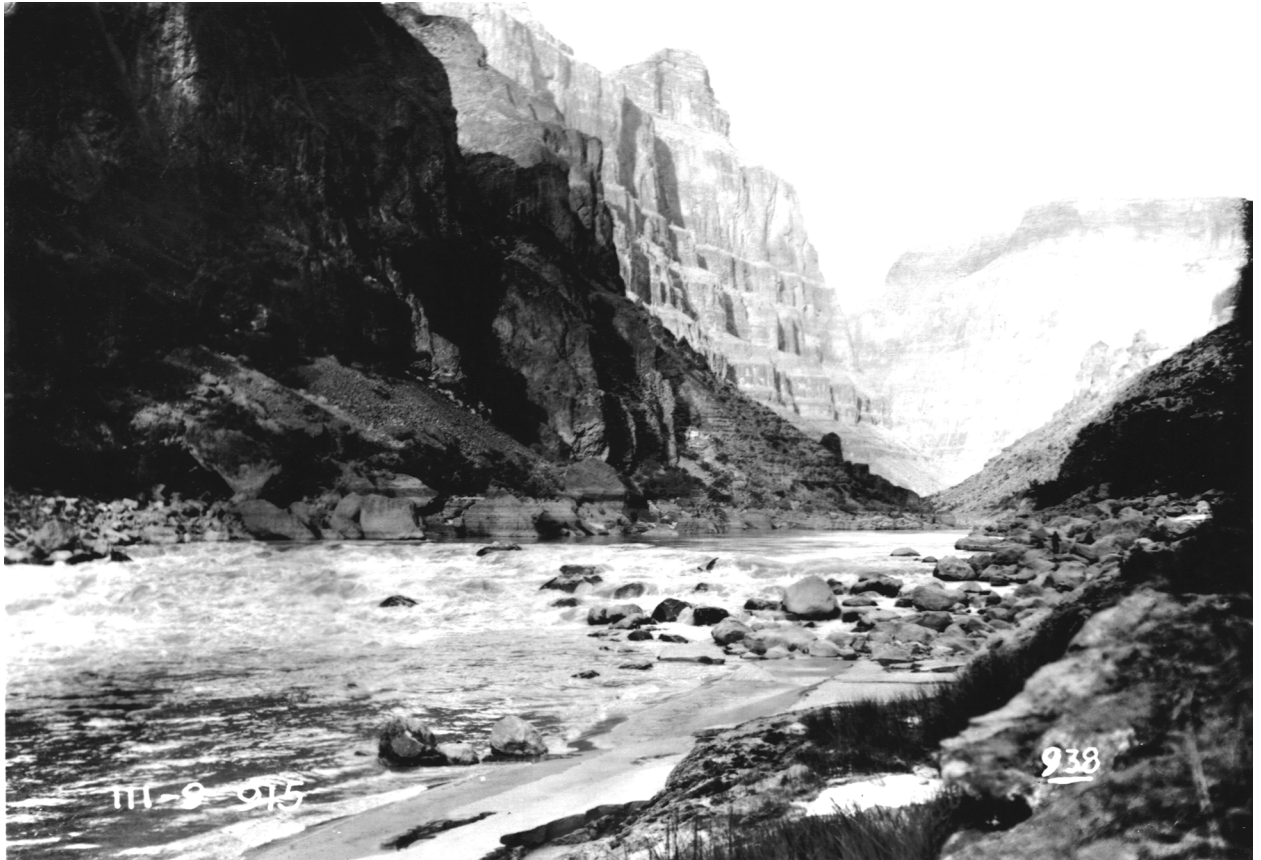
Figure 14. Upstream view of Lava Falls Rapid from the left side (November 10, 1909; R. Cogswell, courtesy of the Bancroft Library, University of California at Berkeley). Boulders that appear on the debris fan and in the river in this view also appear in views taken by Hillers (1872) and Kolb (1912). Photographs taken in 1923 and 1927 show the same boulders, which demonstrates the stability of the rapid in floods of at least $6,200 \text{ m}^3/\text{s}$.

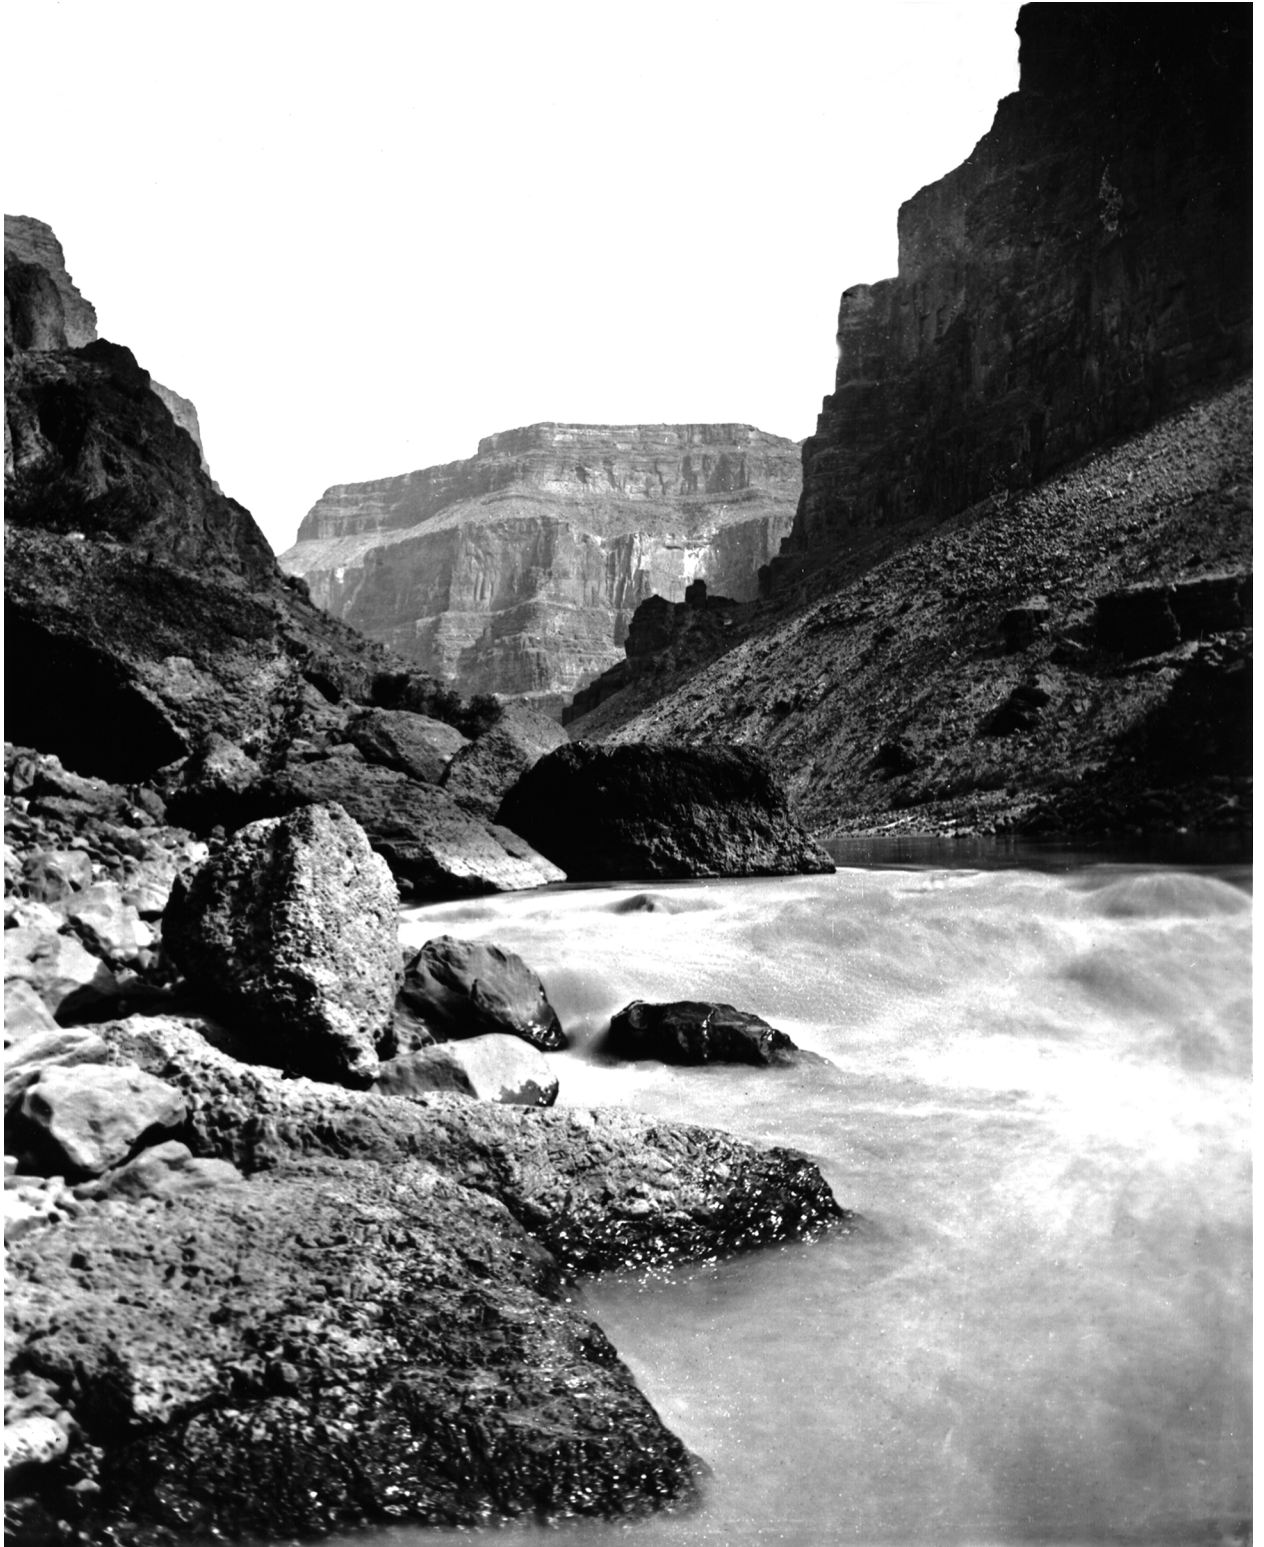
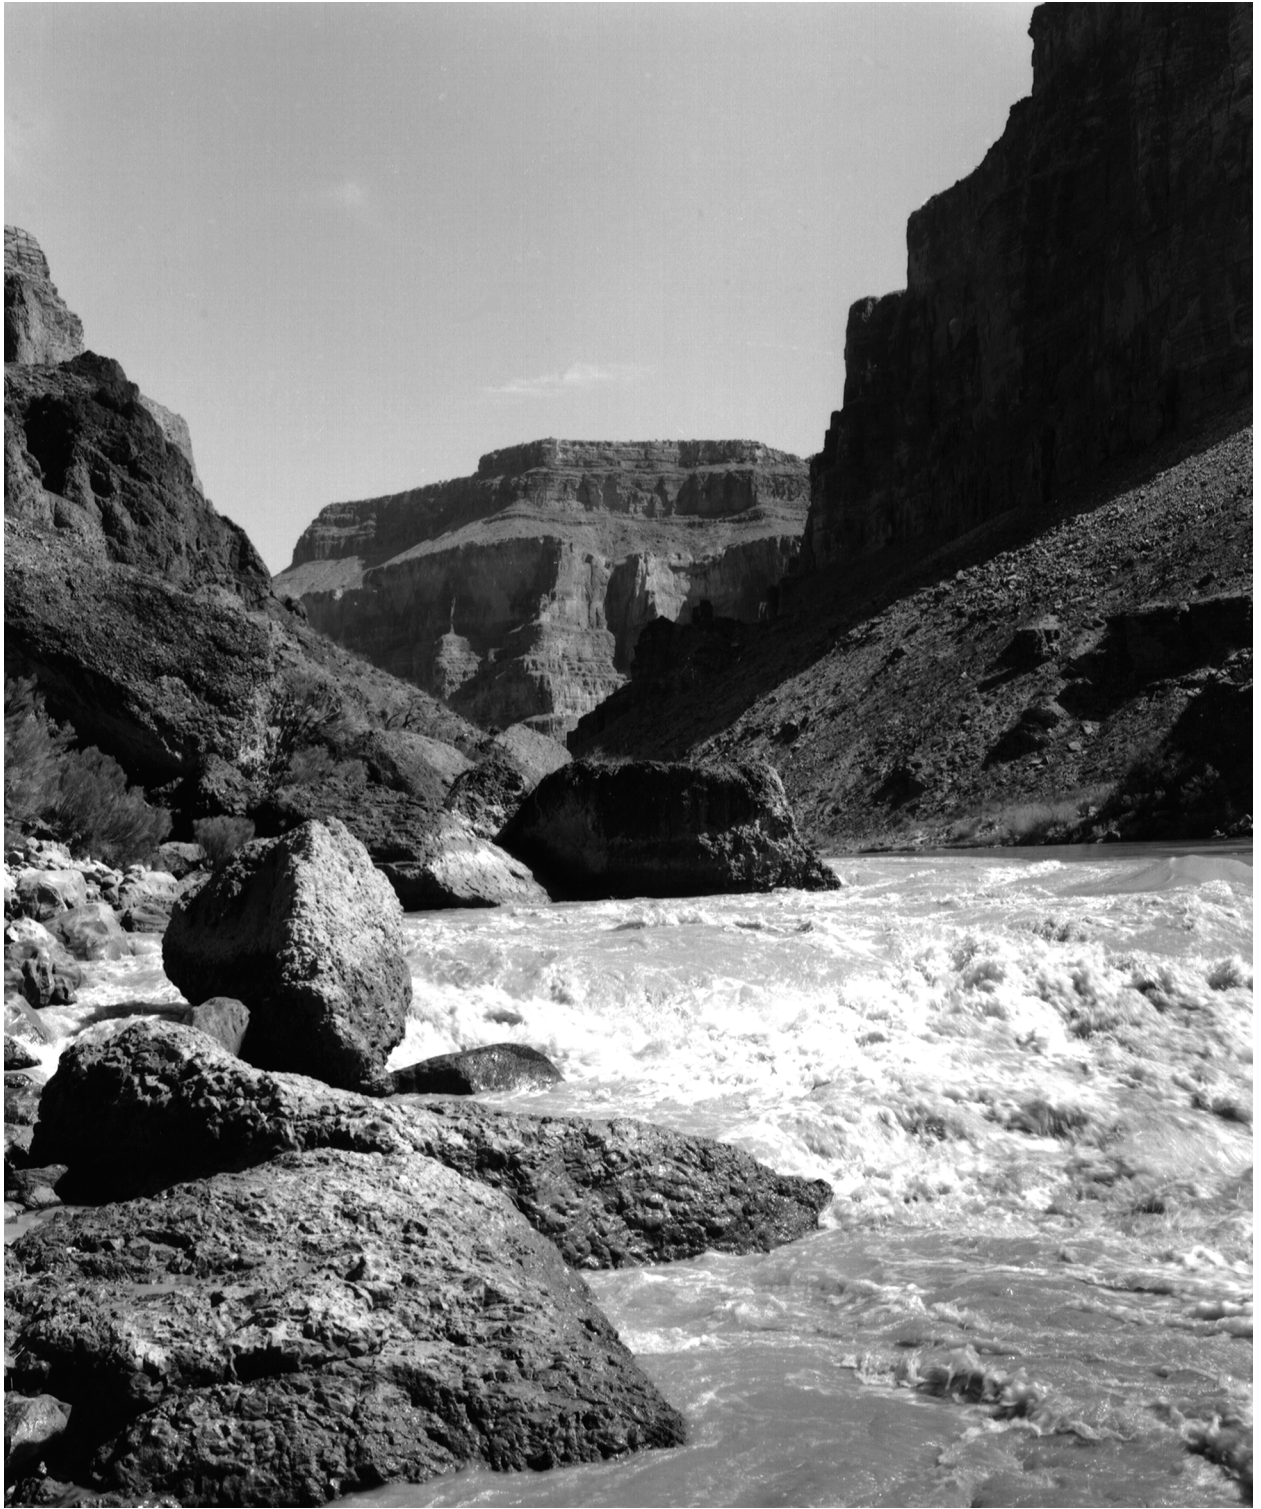
Figure 15. Upstream views of the head of Lava Falls Rapid from the right side (Stakes 2598 and 2662). A. (April 19, 1872; J. K. Hillers, courtesy of the National Archives). At a discharge of about $280 \text{ m}^3/\text{s}$, the Entrance Rock appears in the center; a very small eddy formed behind this rock in 1872. Many rocks and small pourovers are visible in the center of the photograph. This photograph is also shown in Graf (1979).

B. (March 8, 1993; L. Hymans). Even though flow in the Colorado River ($310\text{--}340\text{ m}^3/\text{s}$) is only slightly higher, the stage appears much higher than in 1890. A sizeable eddy forms behind the Entrance Rock. Now, rocks or pourovers are not visible above $140\text{ m}^3/\text{s}$. Also, water flows around the right side of the large basalt boulder in the center of the view.

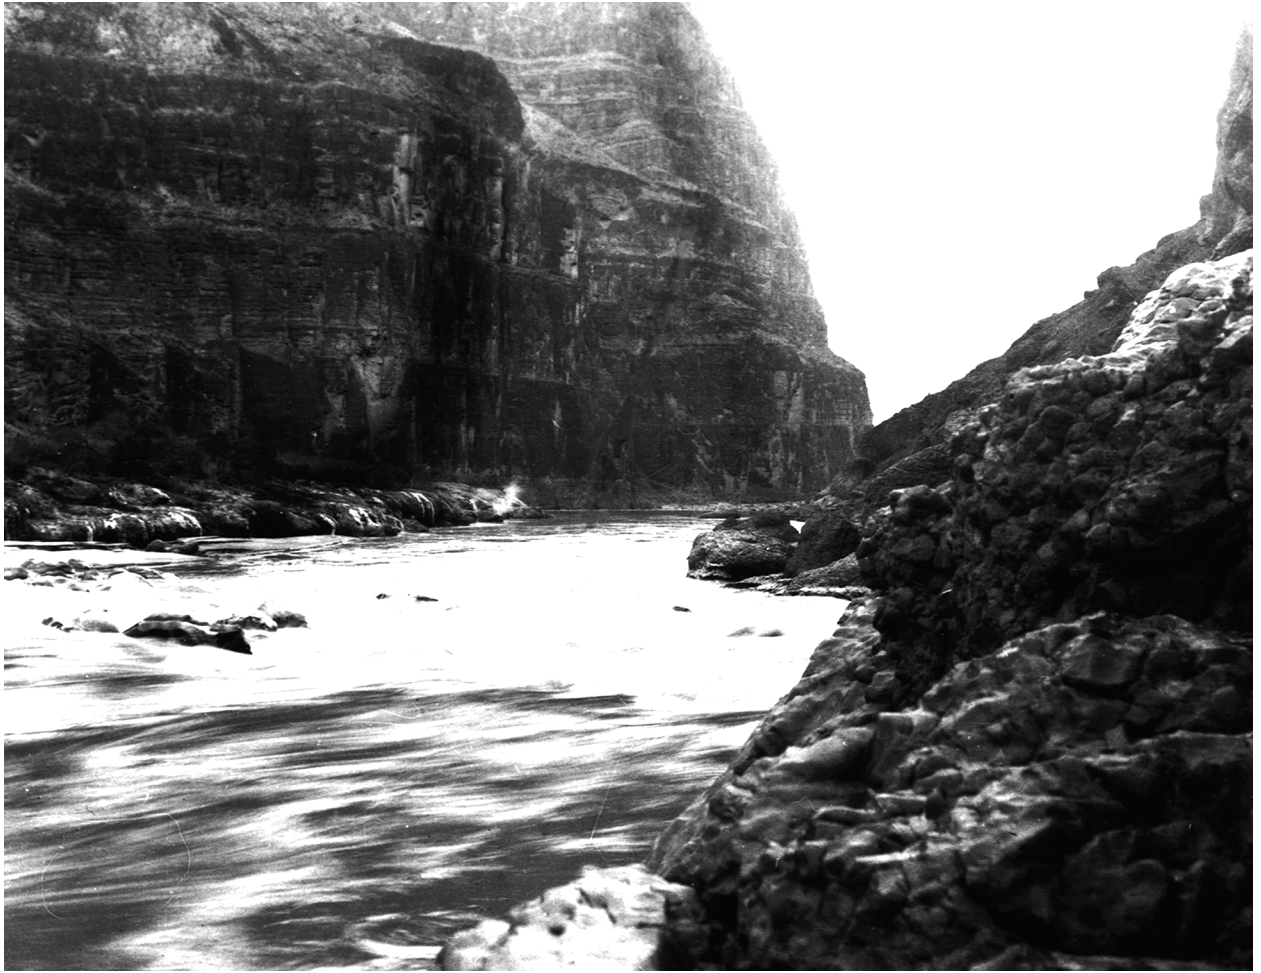
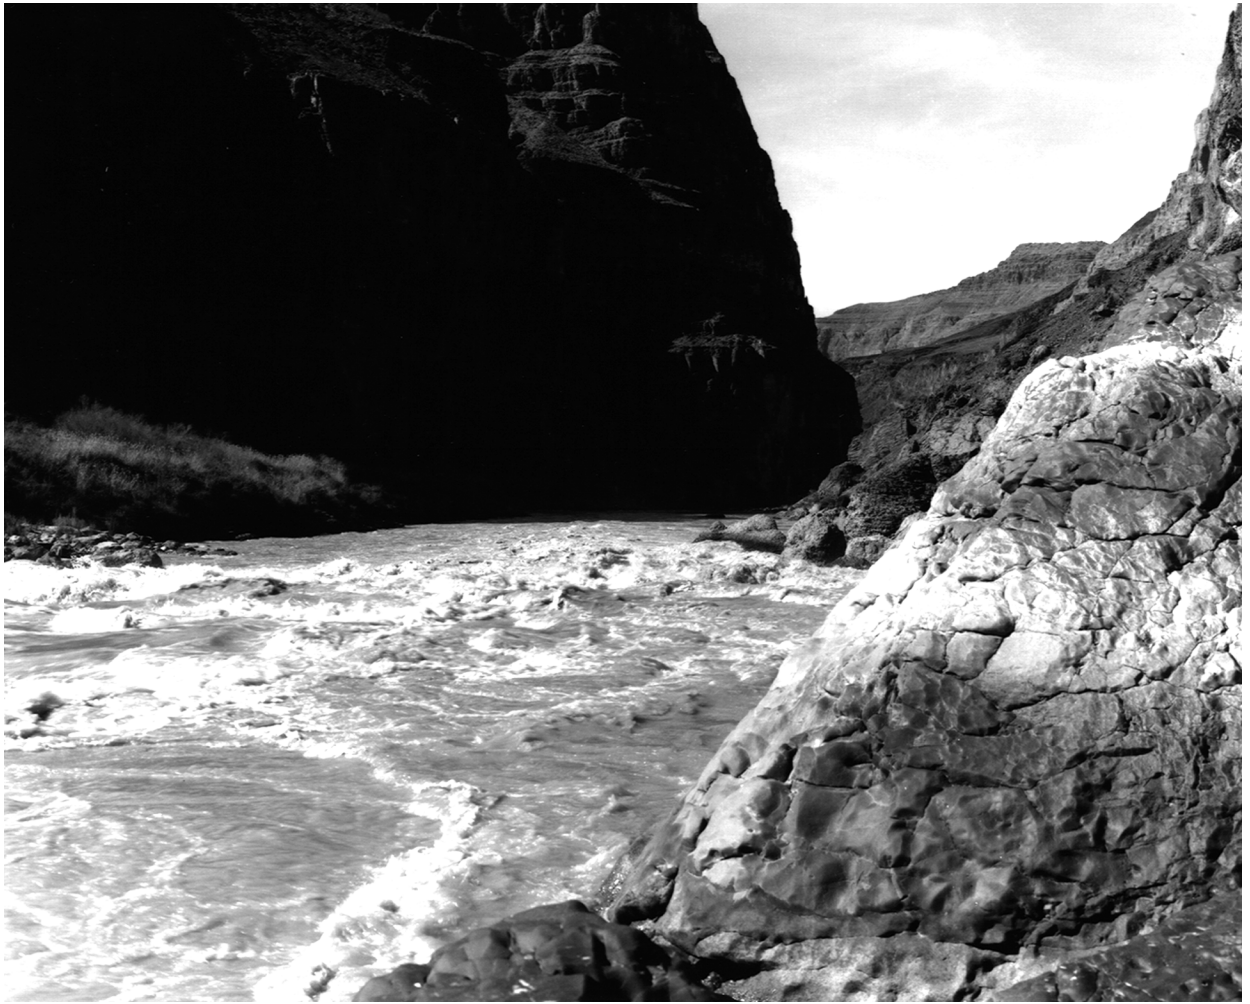
Figure 16. Downstream view of the right side of Lava Falls Rapid (Stake 2599). A. (January 1, 1912; E. Kolb, courtesy of Northern Arizona University Special Collections). The discharge is 28-85 m³/s, and the Deflector Rock, near the right shore, obstructs the view of the Black Rock. The sand bar at the left and rocks that are exposed in the center of the rapid were typically covered at discharges greater than 280 m³/s. Several expeditions, including the Kolb brothers, camped on the sand bar after portaging the rapid

B. (March 9, 1993; L. Hymans). At a discharge of $310 \text{ m}^3/\text{s}$, no rocks are exposed in the center of the rapid. The Deflector Rock was rotated and moved downstream toward the center of the channel and usually is submerged. The Big Wave, to the left of the Black Rock, forms from flow over the submerged boulder. A large part of the basalt boulder in the right foreground has been eroded.

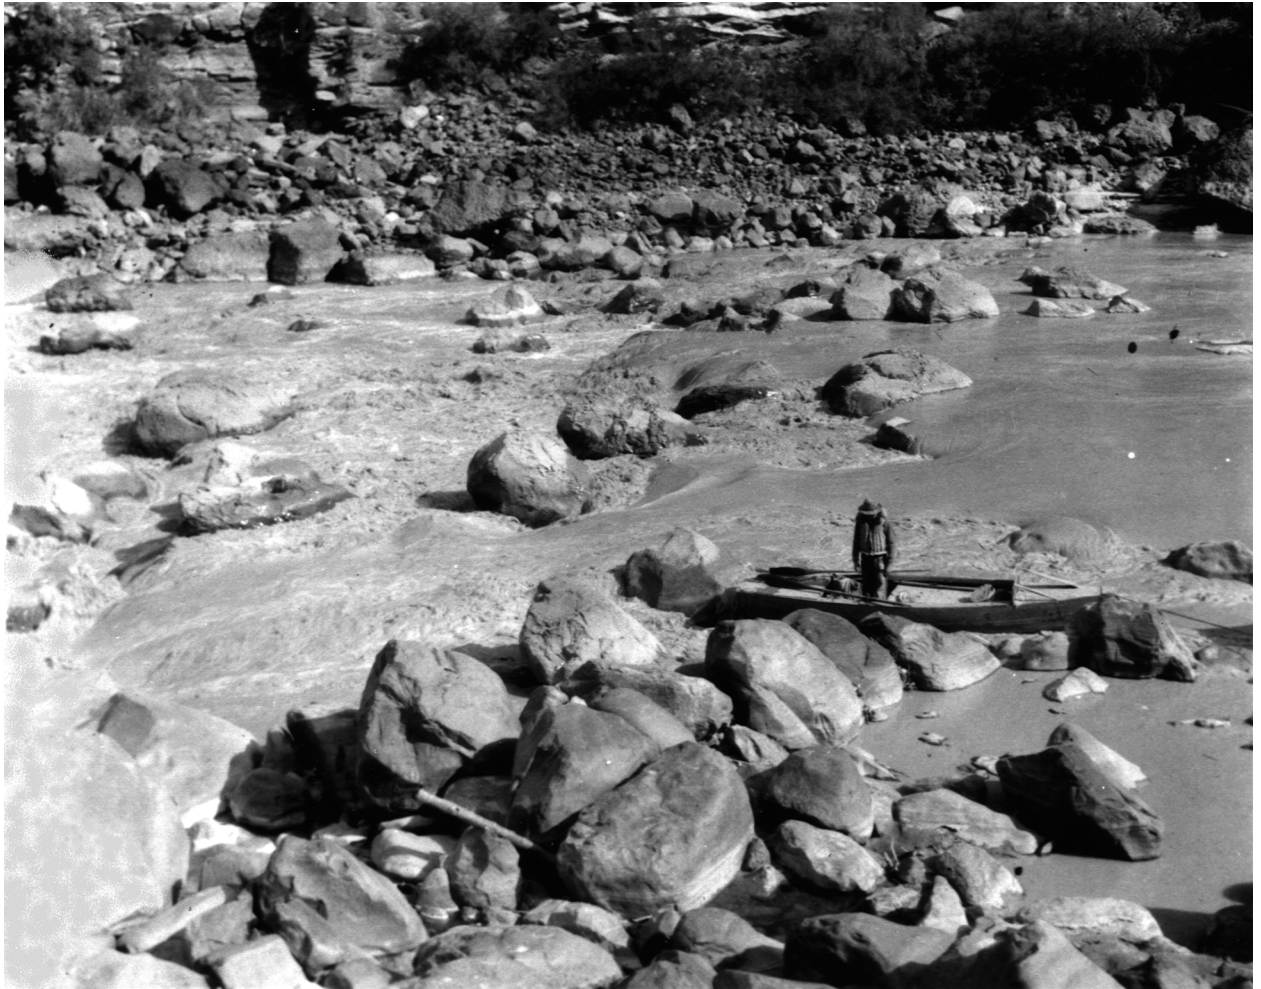
Figure 17. View of Lava Falls Rapid from the left side (July 31, 1934; B. Fahrni, courtesy of the Utah State Historical Society). The crew of the 1934 Frazier-Hatch expedition are lining boats to the head of the rapid to begin a portage. The discharge was $60 \text{ m}^3/\text{s}$, one of the lowest summer levels recorded in the 20th century, and the boulders that form the rapid protrude from the water. The Pyramid Rocks are visible at the upper right of the view. Many of the boulders shown in this view were dislodged or buried by the 1939 debris flow. After 1957, the Ledge Hole formed downstream from the boulders visible in this 1934 view.
